# Evaluation Report 179

## Noble Model NBB7623 (11.9 m) Blade Cultivator

# NOBLE MODEL NBB7623 BLADE CULTIVATOR

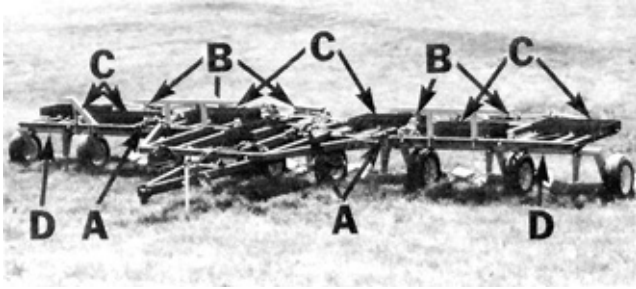
FIGURE 1. Noble Blade Cultivator: (A) Master Cylinders, (B) Wing Lift Cylinders, (C) Weight Boxes, (D) Rockshaft.

Detailed specifications are given in APPENDIX I while FIGURE 1 shows the location of major components.

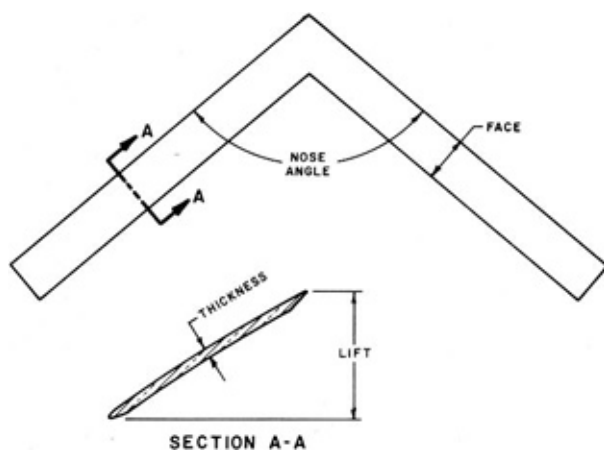
**Shank and Blade Characteristics:** The Noble NBB7623 was equipped with 1.86 m (6.1 ft) wide blades with a 100° nose angle and a lift of 90 mm (3.5 in) (FIGURE 2). Blades with 75° nose angles were also available. A shear bolt near the top of each shank was provided for blade protection.

FIGURE 2. Blade Terminology.

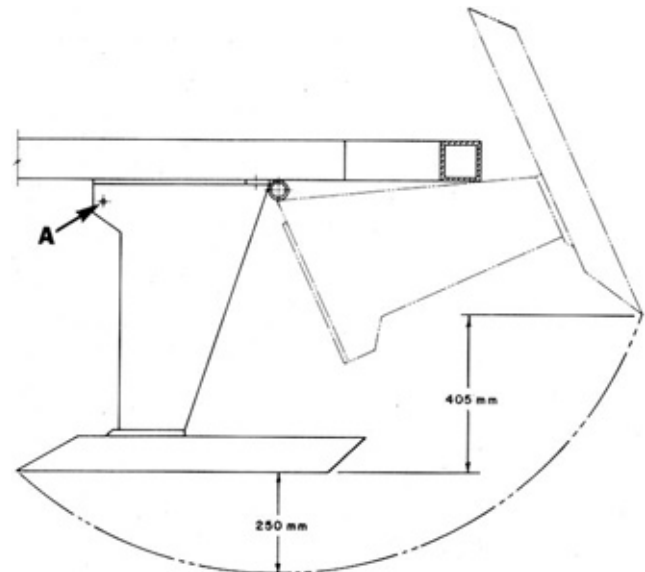
FIGURE 3 shows the lifting pattern when a shank encounters a stone or field obstruction large enough to cause the shear bolt to fail. Maximum lift height was 405 mm (16 in). From FIGURE 3 it can be seen that as the shank and blade assembly pivoted rearward, the blade nose had to move 250 mm (10 in) downward. This forced the frame to be lifted in hard soil conditions. Performance of the shank assemblies was fair. Two shanks and a rockshaft linkage failed when the shear bolt did not shear when a solid obstruction was

encountered. Modifications to reduce shank damage are recommended.

FIGURE 3. Blade Lifting Pattern: (A) Shear Bolt.

1. Modifications to reduce shank damage in stony conditions.
2. Relocating the centre weight box to aid in penetration.
3. Modifying the walking beam axle assembly to prevent rotation.
4. Modifications to improve trash clearance at the centre shank.
5. Modifying the overcentre transport locks on the depth control cylinders to eliminate interference with the depth control stops.
6. Providing a slow moving vehicle sign as standard equipment.
7. Working with the agricultural equipment industry to standardize hydraulic quick couplers and hydraulic hose fitting threads.

1. We are presently working on a self returning trip mechanism for the shank and blade assembly, it will allow the assembly to trip to the rear (without first swinging down) and also to the side to clear obstacles encountered on the wing of the blade.

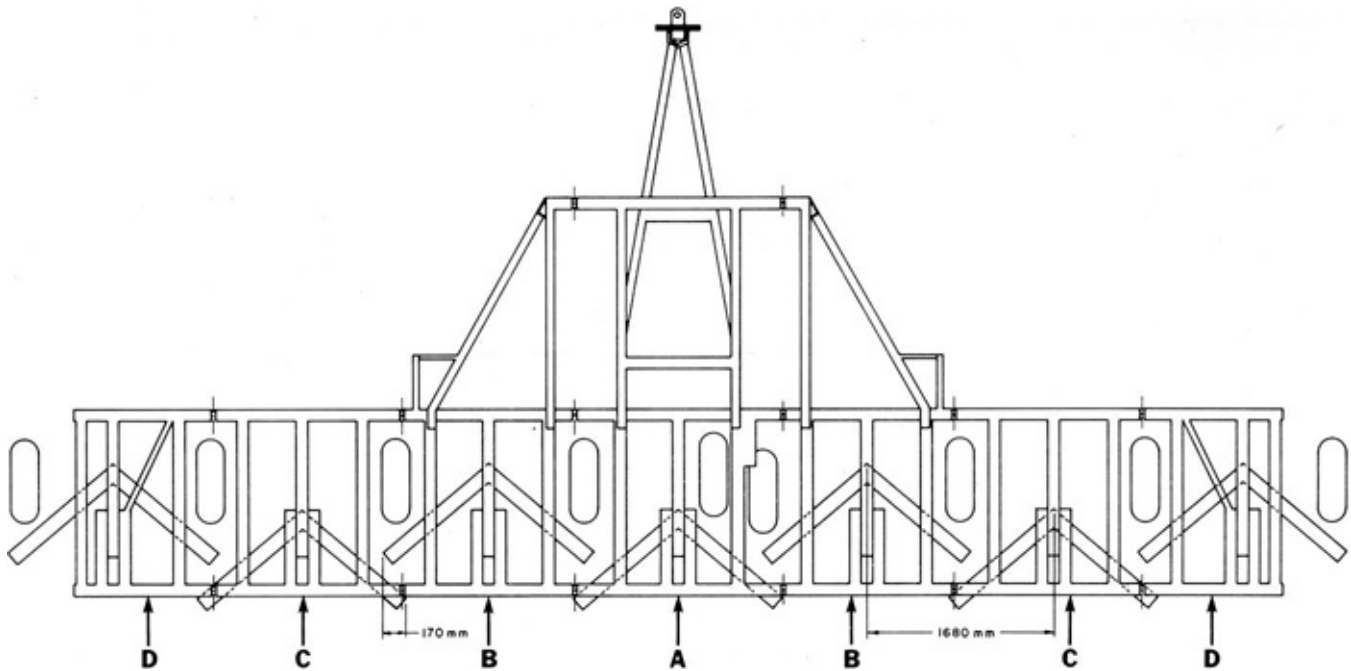
Tires were adequately sized to provide good flotation in all soil conditions. The wheels were positioned (FIGURE 4) so that each of the three centre section wheels supported about 12% of the cultivator weight, the right centre wing wheel about 16%, the left centre wing wheel 8%, each extension wing wheel 15% and each outer wing wheel 5%. In addition, the centre section wheels supported about 14% of the total tillage suction force, the two outer wing wheels 8% and all the other wing wheels 14%. For good flotation and uniform tillage depth across the width, it is desirable to have wheels sized and positioned so that each supports equivalent weight and a similar tillage suction force.

FIGURE 4. Blade Pattern Showing Wheel Location, Shank Spacing and Blade Overlap: (A) Centre Section, (B) Centre Wing Sections, (C) Extension Wing Sections, (D) Outer Wing Sections.

**Weed Kill:** Weed kill was good. The shank spacing of 1680 mm (66 in) resulted in a 170 mm (17 in) sweep overlap (FIGURE 4). Sweep wear did not cause weeds to be missed. Weed kill was occasionally inadequate when the soil moisture was high following tillage. When the top layer of soil remained moist, small lateral roots continued to grow. In moist soil, shallow tillage depth increased soil disturbance and produced a better weed kill.

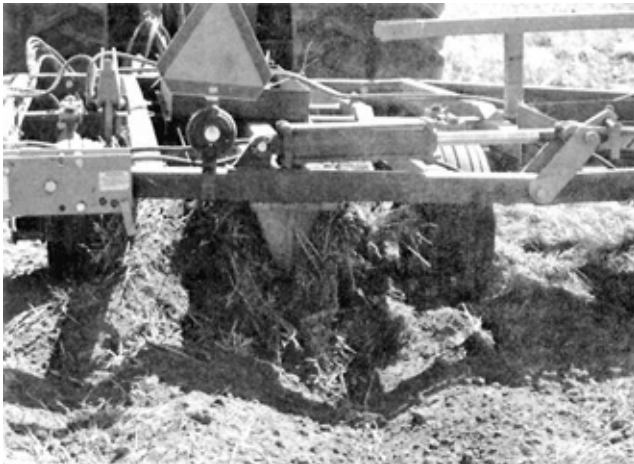
**Plugging:** Trash clearance was good. The Noble NBB7623 was capable of clearing medium to heavy trash. Plugging occurred in loose, heavy trash, between the dual centre wheels and the centre shank (FIGURE 5) which were only 205 mm (8 in) apart. Initial plugging at the centre shank was not always noticed as operator visibility of the centre shank was reduced by the centre weight box. Modifications to provide more clearance are recommended.

FIGURE 5. Plugging at the Centre Shank.

3. We are presently making the walking beam axles with stops to prevent overcentering. We have available a bolt-on strap to upgrade older machines.
4. There is a mounting location for the center shank at the extreme rear of the frame. Mounting the center shank in this location provides an additional 6 inches of clearance which should be enough to eliminate most plugging problems.

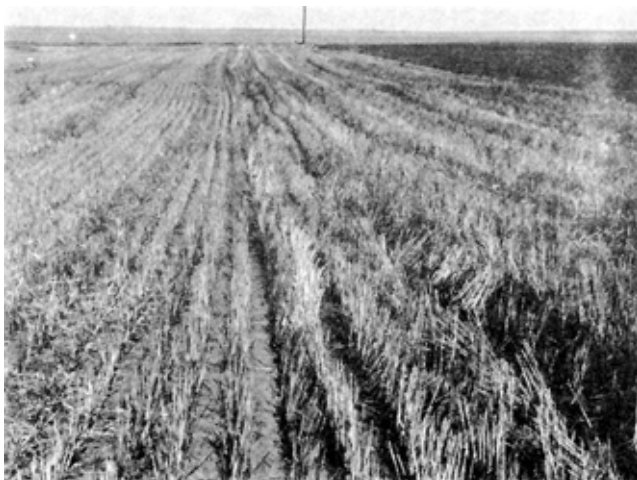
**Trash Burial and Field Surface:** The Noble NBB7623 buried very little trash. The majority of stubble was left standing and anchored to the soil, resulting in very little difference in field appearance before and after tillage (FIGURE 6). Some trash was buried in the small furrows left by the shanks. The amount of trash buried in the furrows depended on the depth and speed of tillage and the soil conditions.

FIGURE 6. Trash Cover Before (left) and After (right) Tillage at 75 mm Depth and 8 km/h.

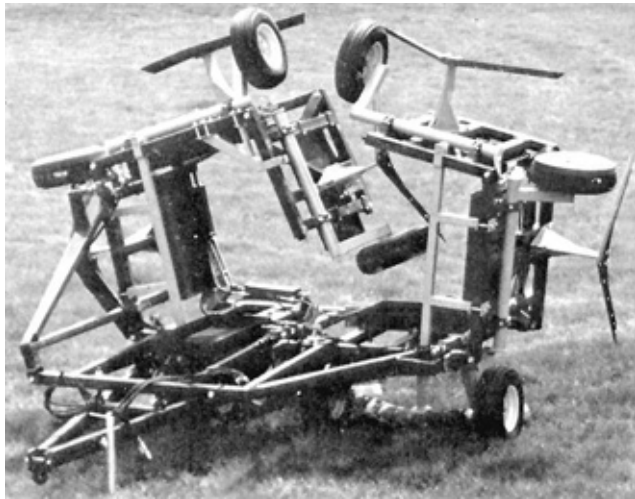
**Transporting:** The Noble NBB7623 was easily placed in transport position (FIGURE 7) using the hydraulic wing lift system supplied as standard equipment. Eleven pins, which had to be inserted by hand, were provided to fold and lock the wings for transport. Mechanical overcentre transport locks were also supplied for each depth control cylinder. Interference between the locks and fully extended depth control stops (FIGURE 8) prevented complete overcentre locking. It is recommended that the manufacturer consider modifications to eliminate this interference. Raising or lowering, depending on the tractor hydraulics, took one man less than ten minutes, providing there were no weights in the weight boxes. Weights had to be removed before raising the wings.

Transport width was 5.8 m (19 ft) while transport height was 3.9 m (12.9 ft). The hitch weight, in transport position, was 50 kg (110 lb), making the Noble stable while towing. It towed well at transport speeds up to 32 km/h (20 mph). Sweep to ground clearance during transport was 140 mm (5.5 in), while transport wheel tread was 3.1 m (10 ft). This usually provided ample ground clearance.

FIGURE 7. Transport Position.

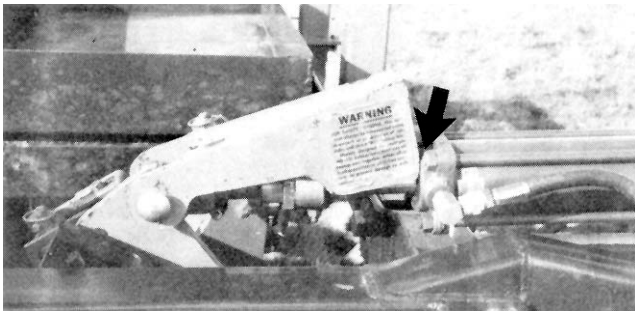
FIGURE 8. Interference Between Transport Locks and Depth Control Stop Collars.

5. The overcenter lock has been modified to allow it to drop down over the depth control stops when they are fully extended.
6. We will provide a slow moving vehicle sign as standard equipment on upcoming runs. We also intend to have reflectors on the front and rear corners of the machine for safer night transporting.

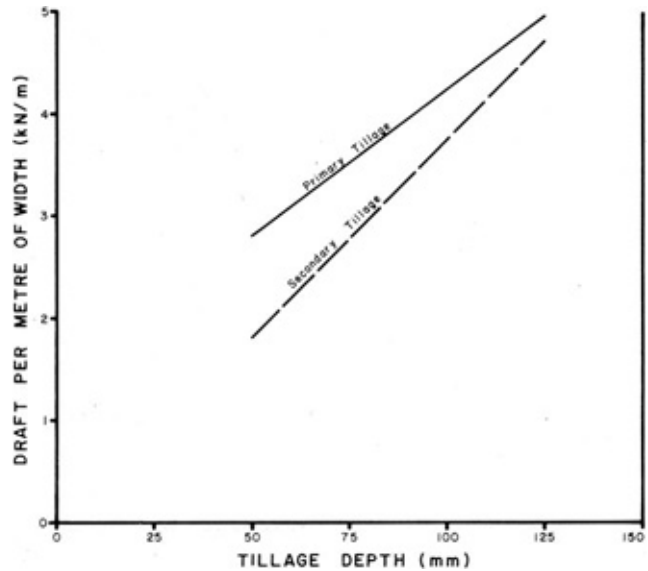
**Draft Characteristics:** FIGURE 9 shows draft requirements for blade cultivators in typical primary and secondary tillage at a speed of 8 km/h (5 mph). This figure gives average requirements based on tests in 10 different field conditions. Attempting to compare draft requirements of different makes of blade cultivators, usually is unrealistic. Draft requirements for the same cultivator, in the same field, may vary significantly due to changes in soil conditions. Variation in soil conditions affect draft much more than variation in machine make, usually making it impossible to measure any significant draft differences between different makes of blade cultivators.

In primary tillage average draft per metre width, at 8 km/h (5 mph), varied from 2.9 kN (604 lb) at 50 mm (2 in) depth to 5.0 kN

(1100 lb) at 1.25 m (5 in) depth corresponding to a total draft from 34.5 to 59.5 kN (7590 to 13,090 lb) for the 11.9 m (39 ft) test machine.

In secondary tillage, average draft per metre of width at 8 km/h (5 mph) varied from 1.9 kN (420 lb) at 50 mm (2 in) depth to 4.7 kN (1030 lb) at 125 mm (5 in) depth. This corresponds to a total draft ranging from 22.6 to 55.9 kN (4970 to 12,300 lb) for the 11.9 m (39 ft) test machine.

Increasing speed by 1 km/h (0.6 mph) increased draft by about 90 N (20 lb) per metre of width. For the 11.9 m (39 ft) wide test machine, this represents a draft increase of about 1.1 kN (240 lb) for a 1 km/h (0.6 mph) Speed increase.

FIGURE 9. Average Draft Requirements for Blade Cultivators at 8 km/h.

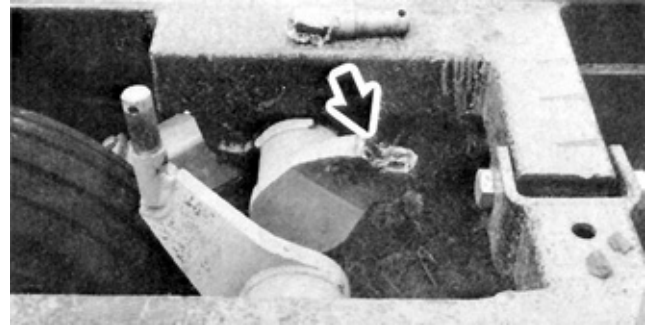
**Shanks:** One shank cracked and another was bent when the shear bolts failed to shear upon encountering field obstructions. This also caused failure of a turnbuckle rockshaft pin (FIGURE 10).

FIGURE 10. Turnbuckle Pin Failure.
